2006 Restoration Day: Trent Hall Site
Status Update
As of September 2006

Update from Rich Takacs, NOAA Restoration Center

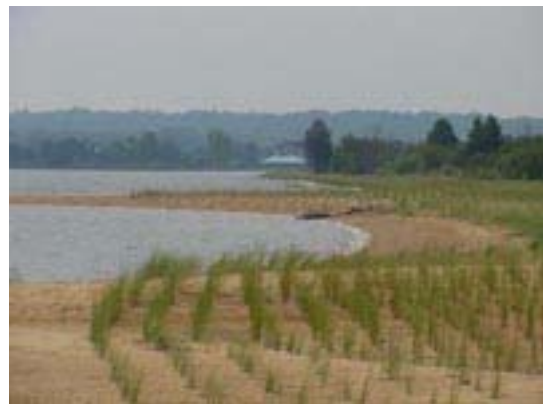
The beach area continues to be quite stable, with only minor, expected shifts in sand locally, but no appreciable net loss or gain. The *Spartina alterniflora* that was planted in limited areas at the beach site is struggling to hang on in a couple of places, but I think we are right on the verge where that material can tolerate energy wise (Walter Priest had said that previously).

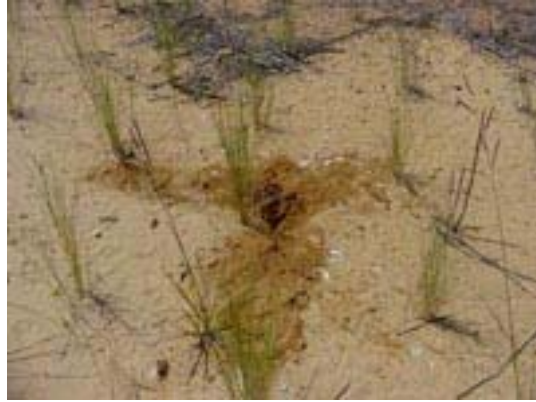
The beach has gotten extensive use by terrapins nesting this summer, though natural predation by foxes and raccoons can be pretty high. When we were there in July, we were able to count over 60 nests in just that day, so undoubtedly there were a lot more than that over the season. The back beach *S. patens* continues to grow, with good plant height, and we expect lots of seed dispersal to occur this fall, which should really help fill the site in over the next year.

Terrapin nest at beach area

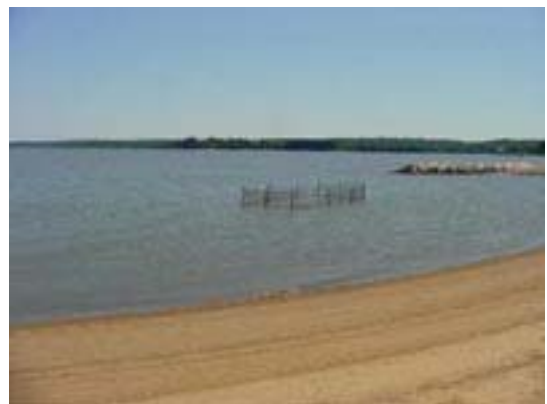
Lastly, it appears that our test plantings of underwater grasses grown in NOAA offices were indeed just that, test plantings. When we visited the site in mid-August, the enclosure was still intact, but all of the plant material inside of it was gone. When Peter Bergstrom checked the water clarity (recall that is principally the limiting factor for SAV in the mid-Patuxent), it was pretty poor that day. Though this is disappointing for volunteers (especially those who helped to grow the grass), the information learned through this type of test helps Bay scientists to better understand and predict successful plantings in the future.

Possible Reasons Why the Trent Hall SAV planting failed:

Water quality monitoring data collected by Maryland Department of Natural Resources show that the Patuxent has a strong and consistent gradient of water clarity--clearer water near the

mouth. Trent Hall is several miles north of the zone where water clarity should be adequate to support SAV growth. (Some SAV transplants have survived at Jefferson Patterson Park, within the zone where SAV was expected to survive). Peter Bergstrom hoped that by planting them in shallow water they might survive, but this did not happen. For more information about where SAV planting has been successful in the Patuxent, see: http://www.dnr.state.md.us/bay/sav/restoration/pax_gen_info.asp
